Public Information Statement National Weather Service Melbourne FL 626 PM EDT Fri Apr 28 2023

... NWS Damage Survey for 04/26/2023 Thunderstorm Wind Event in West Melbourne...

.West Melbourne Thunderstorm Wind Event...

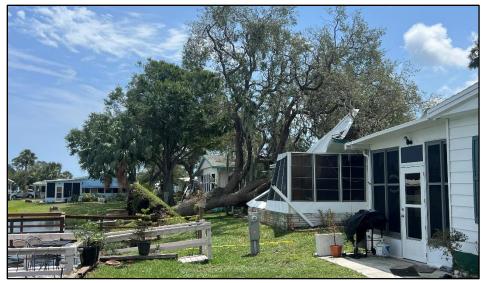
Figure 1. A tree along a lake fell onto a home in Lamplighter Village in West Melbourne, FL. (Photo: Will Ulrich)

The severe thunderstorm continued southward into the Lamplighter Village retirement community, where approximately 50 homes were affected with at least minor damage. These homes suffered partial damage to carports, awnings, and siding. Several lake front homes along Lamplighter Dr. lost their carport and porch awnings, and one experienced major damage when a large oak tree fell onto the residence.

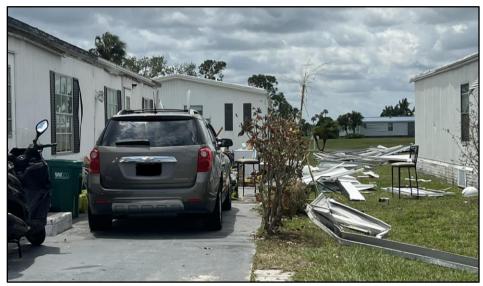
Figure 2. Damage to the carport of a home in Lamplighter Village in West Melbourne, FL. (Photo: Will Ulrich)

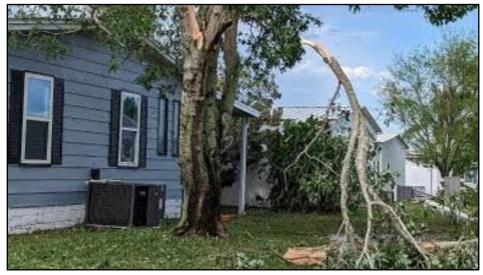
Figure 3. Several large tree branches fell near a home in Lamplighter Village in West Melbourne, FL (Photo: Will Ulrich)
